Water Compliance Inspection Report

***NPDES
Inspection Report***

***Sterk Dairy of Whatcom County Inc.
Lynden, WA***

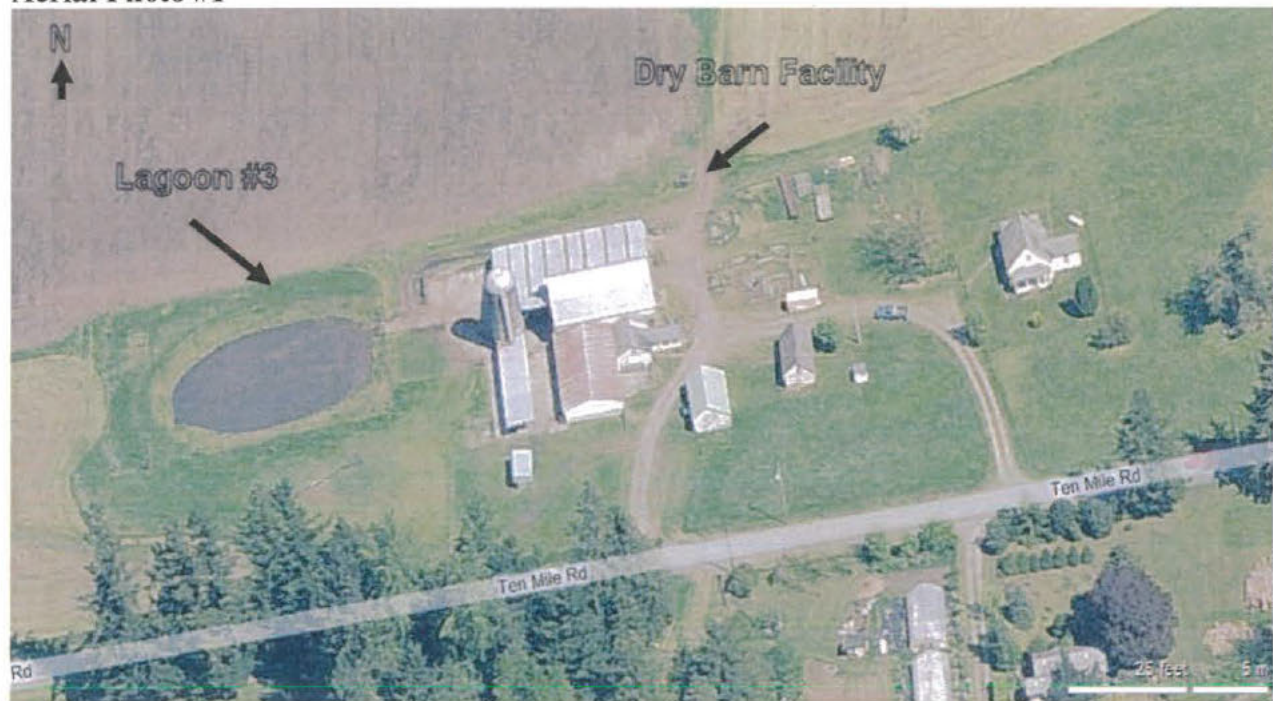
Aerial Photo #1

The farm has two other confinement areas; a "dry barn" located about a half mile east of the main facility, and a "heifer barn" located about a half mile west of the main facility. (See attachment A for aerial maps). These two areas are where dry cows and heifers are kept. These other confinement areas were also inspected along with the main facility.

At the dry barn facility, all animal waste is scraped from the confinement area directly to the waste lagoon located just west of the confinement area (See attachment A for an aerial map). Waste is then land applied to nearby fields as needed.

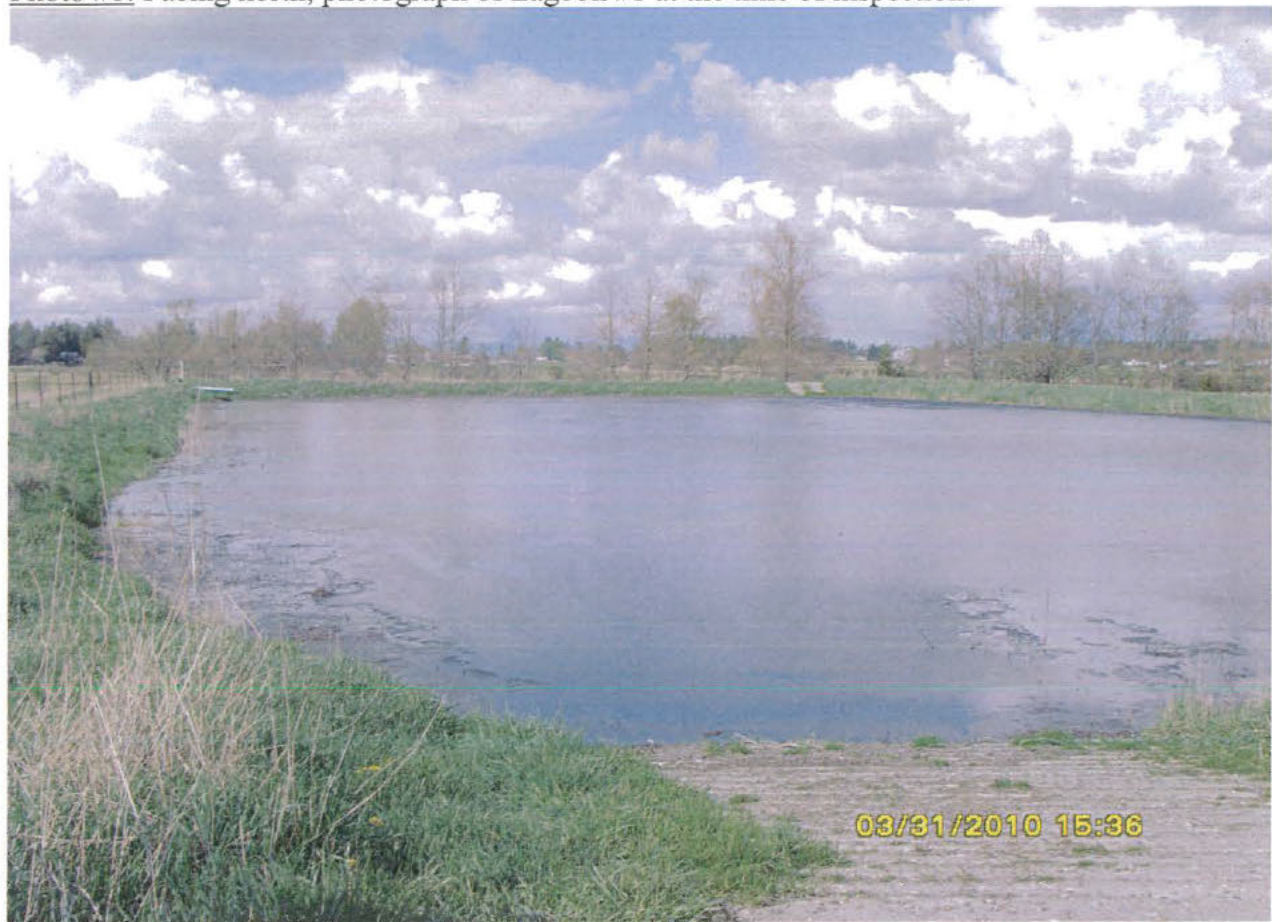
Photo #1: Facing north, photograph of Lagoon #1 at the time of inspection.

Following the records review we proceeded to conduct a tour of the dairy facility. The facility tour consisted of an inspection of the animal confinement pens and the confinement pen perimeter at each facility. This inspection also included a tour of the facility waste handling systems and land application fields. See Attachment B, Photo #1 Photo #2 and Photo #3, showing lagoon levels at time of inspection.

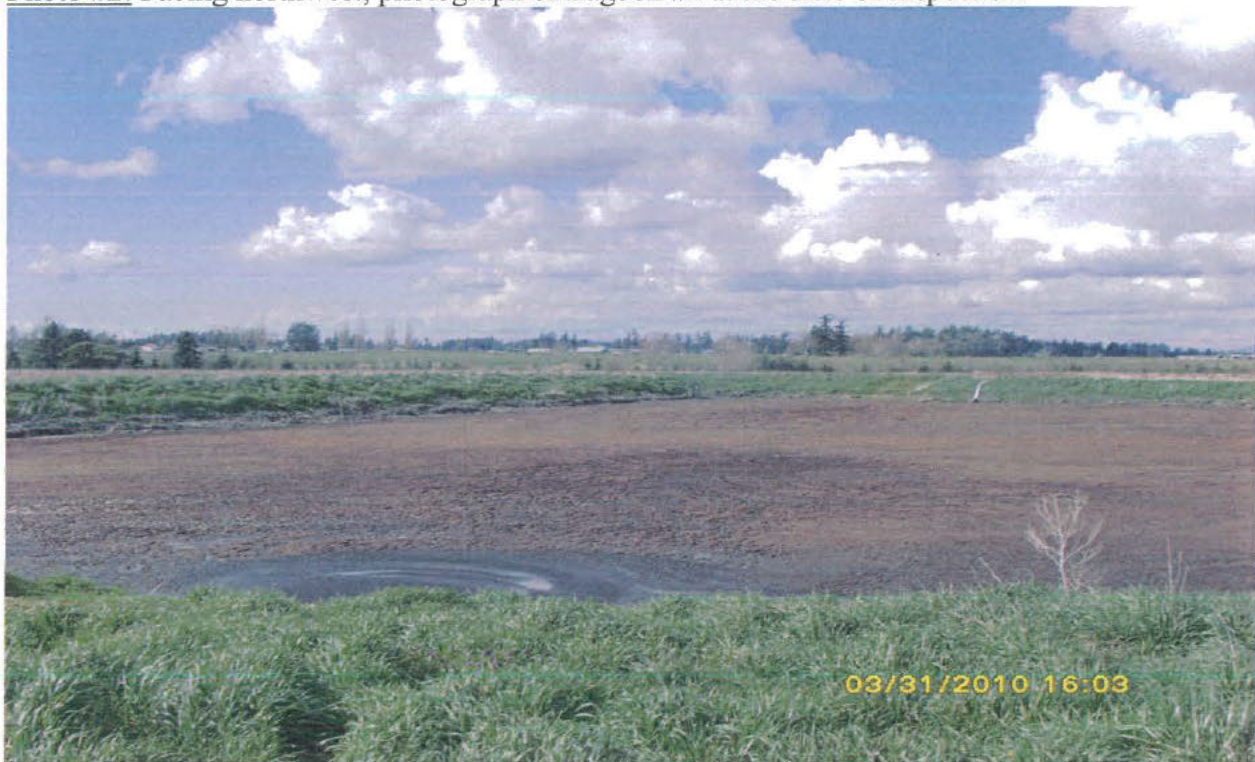
Photo #2: Facing northwest, photograph of Lagoon #2 at the time of inspection.

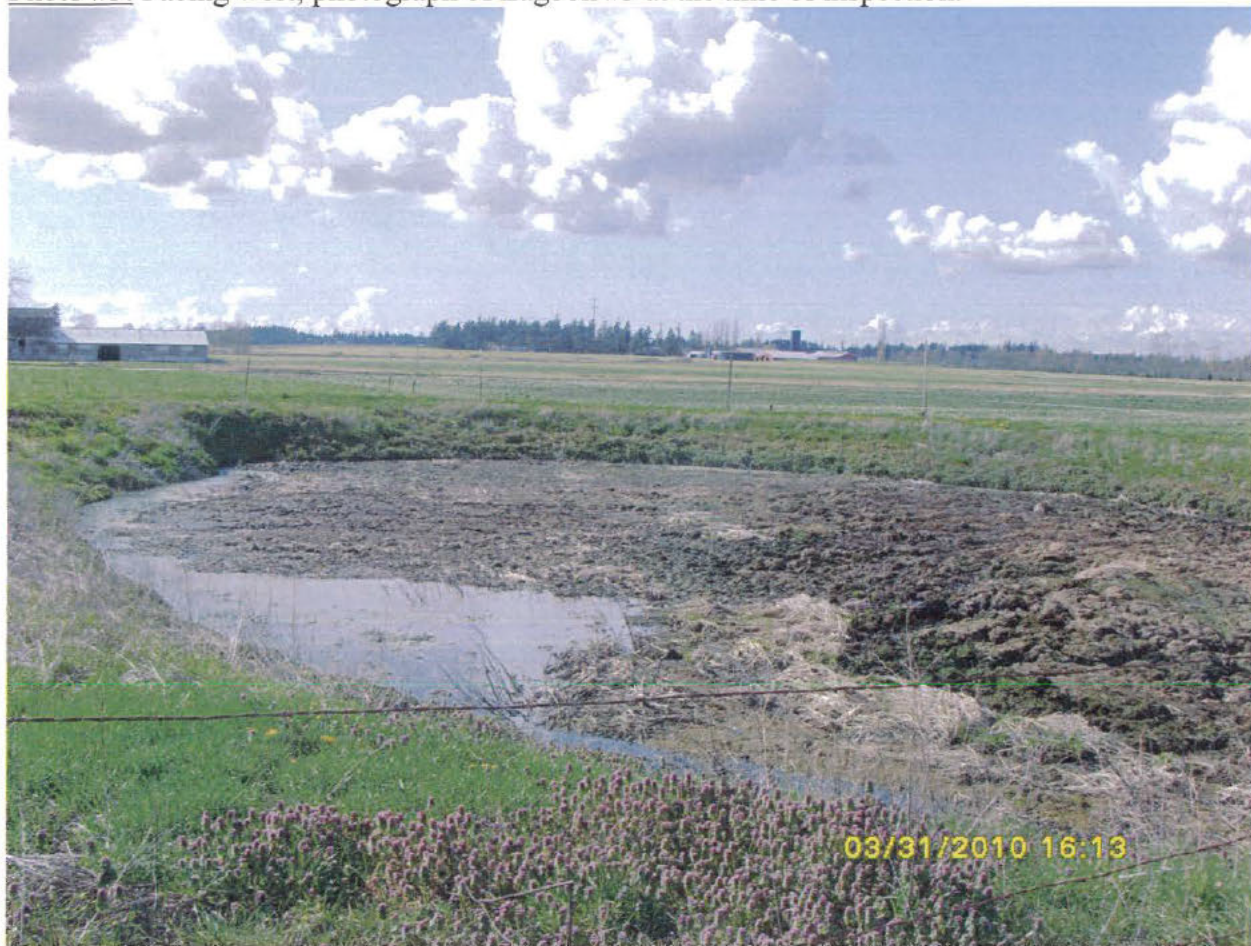
Photo #3: Facing west, photograph of Lagoon #3 at the time of inspection.

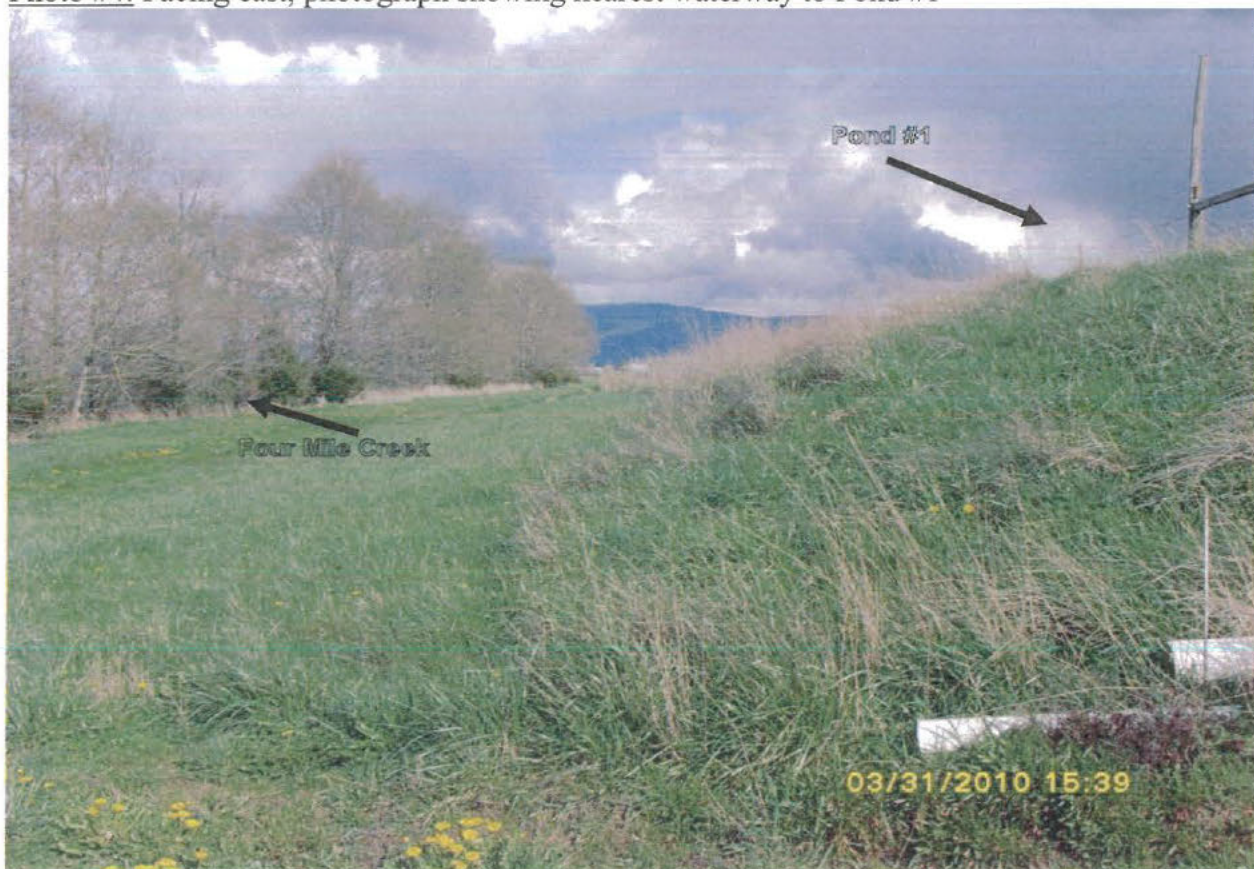
The nearest waterway is the Four Mile Creek which runs from east to west about 200 ft directly north of Lagoon #1 at the main facility. See attachment B, Photo #4 which shows the location of the nearest waterway.

Photo #4: Facing east, photograph showing nearest waterway to Pond #1
